Manhole Inspection Summary

Manhole # S51AA_007MH

Insp Date: **2/27/08 9:19 AM**

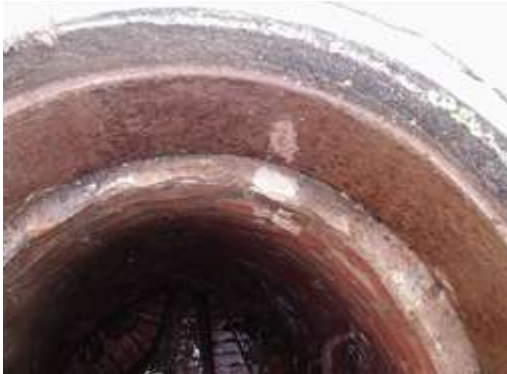
Defect 1

Frame Offset: **1** (in.)

OFFSET

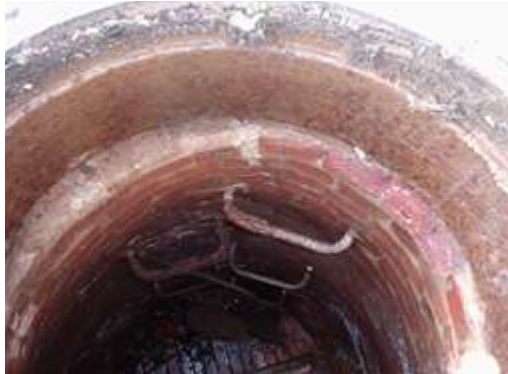
Defect 2

☒ **Leaks**

frame leaks

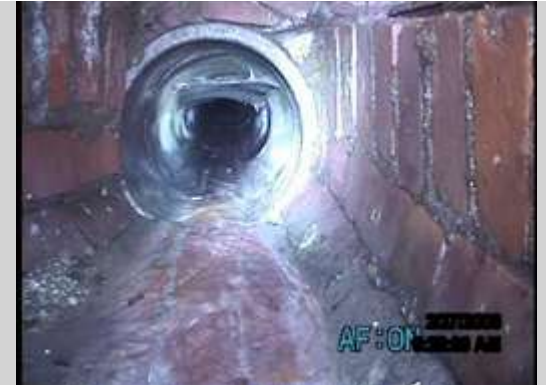
12 O'Clock Outflow

8 in. Circular Gravity Sewer
Pipe Out @ 12 O'Clock

Pipe Height: **8.4** (in.) Rod and Bar (Angled)
Pipe Material: **Clay** ☐ Pipe Lined
Invert Depth: **9.40** (ft.) Flow Characteristics: **Fast**
Deposits: ☒ None ☐ Mud ☐ Sludge ☐ Debris ☐ Grease
Silt Depth: (in.) Deposits Extent:
Infiltration: **None** Pipe Seal Cond: **Sound**

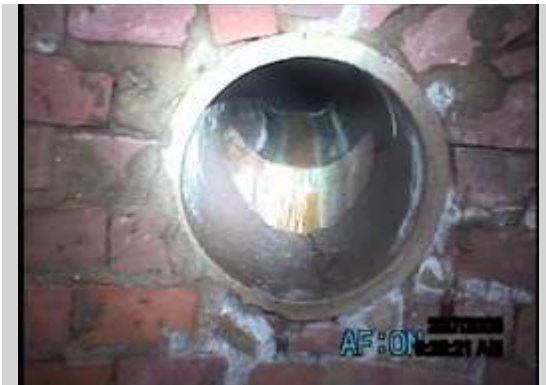
6 O'Clock Inflow

8 in. Circular Gravity Sewer
Pipe In @ 6 O'Clock

Drop In @ 6 O'Clock

Pipe Height: **8.4** (in.) Rod and Bar (Angled)
Pipe Material: **Clay** ☐ Pipe Lined
Invert Depth: **8.00** (ft.) Flow Characteristics: **Fast**
Deposits: ☒ None ☐ Mud ☐ Sludge ☐ Debris ☐ Grease
Silt Depth: (in.) Deposits Extent:
Infiltration: **None** Pipe Seal Cond: **Sound**

Drop: **Inside** Rod and Bar
Angled: **Yes** Reading: **8.50** (ft.)
Inv Depth: **9.50** (ft.)

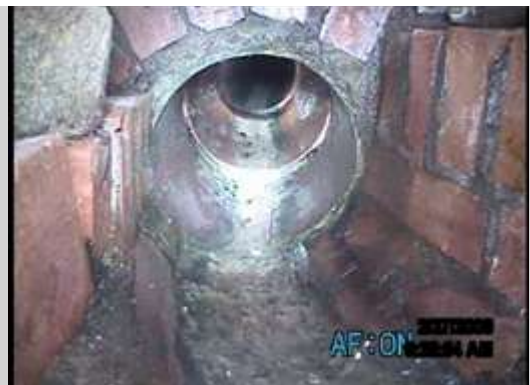
9 O'Clock Inflow

8 in. Circular Gravity Sewer
Pipe In @ 9 O'Clock

Pipe Height: **8.4** (in.) Rod and Bar (Angled)

Invert Depth: **9.40** (ft.) Flow Characteristics: **Fast**

Pipe Seal Cond: **Sound**
